An Assessment of Shore Erosion in Northern Chesapeake Bay

1982

tidewater administration. maryland dept. of natural resources.

AN ASSESSMENT OF SHORE EROSION IN NORTHERN CHESAPEAKE BAY
AND OF THE PERFORMANCE OF EROSION CONTROL STRUCTURES

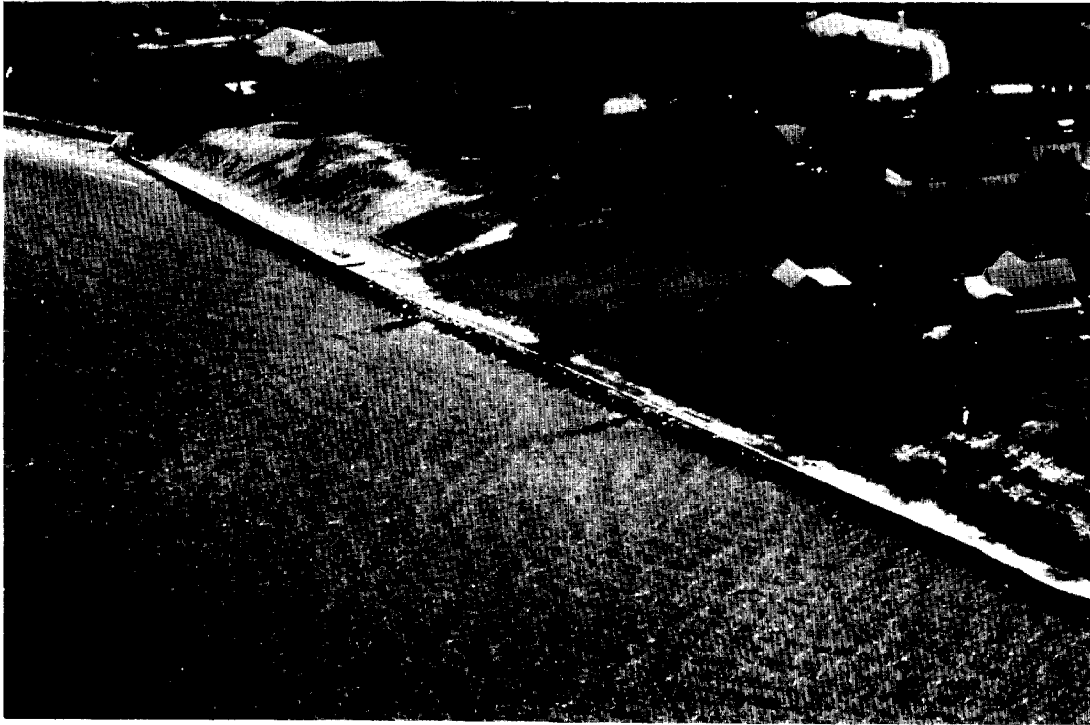
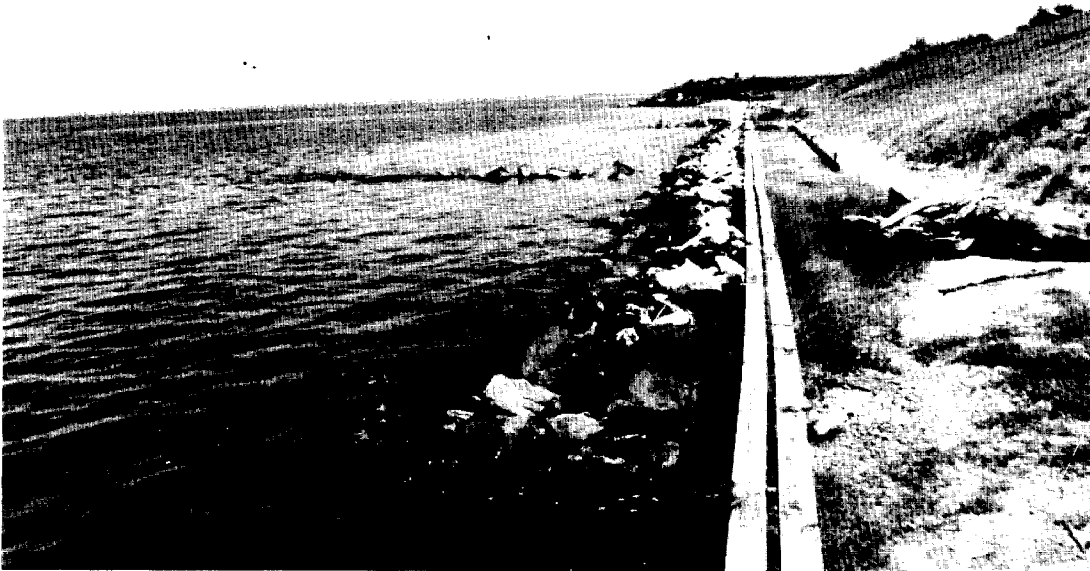
CASE 36 TIMBER BULKHEAD WITH STONE
 REVTMENT ON KENT ISLAND

Ponded water on the fastland behind the bulkheading is a problem which needs correction. According to talks with local residents, the primary cause of damage to the structure has been winter ice, which displaces the stones in the rip-rap section.

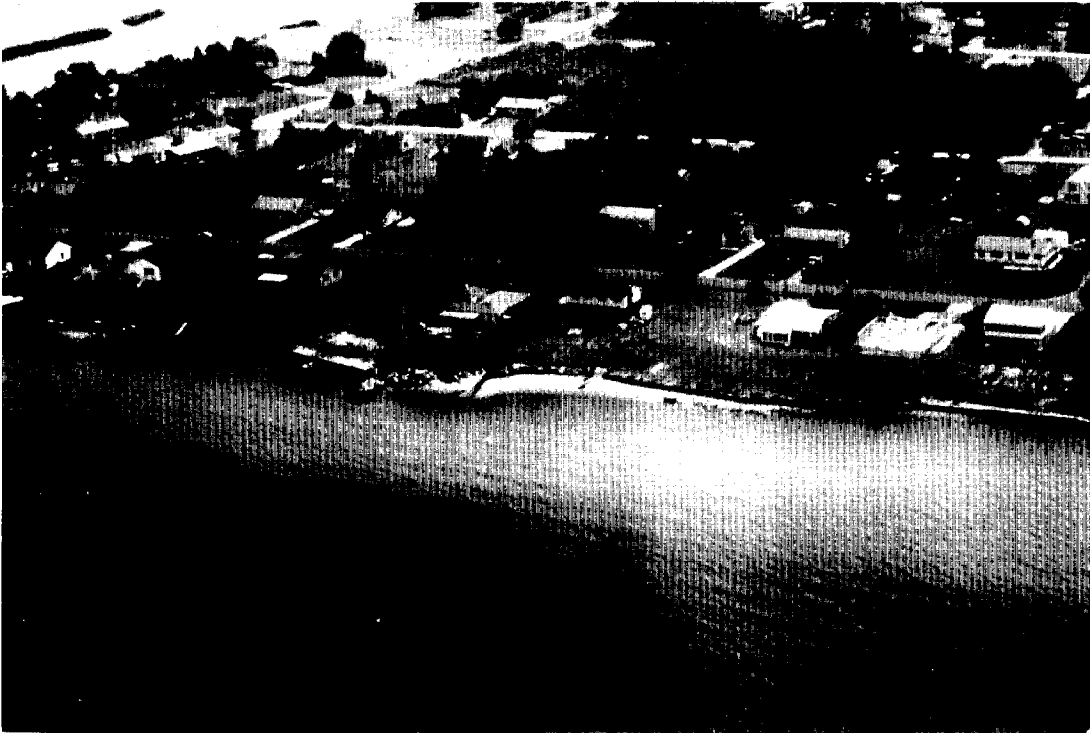
CASE 38 GABIONS ON KENT ISLAND

This structure is in generally good condition. At the time of the site visit, the structure was holding a nice sandy beach extremely well. However, there is some evidence that the baskets holding the stones are deteriorating due perhaps to abrasion and corrosion.

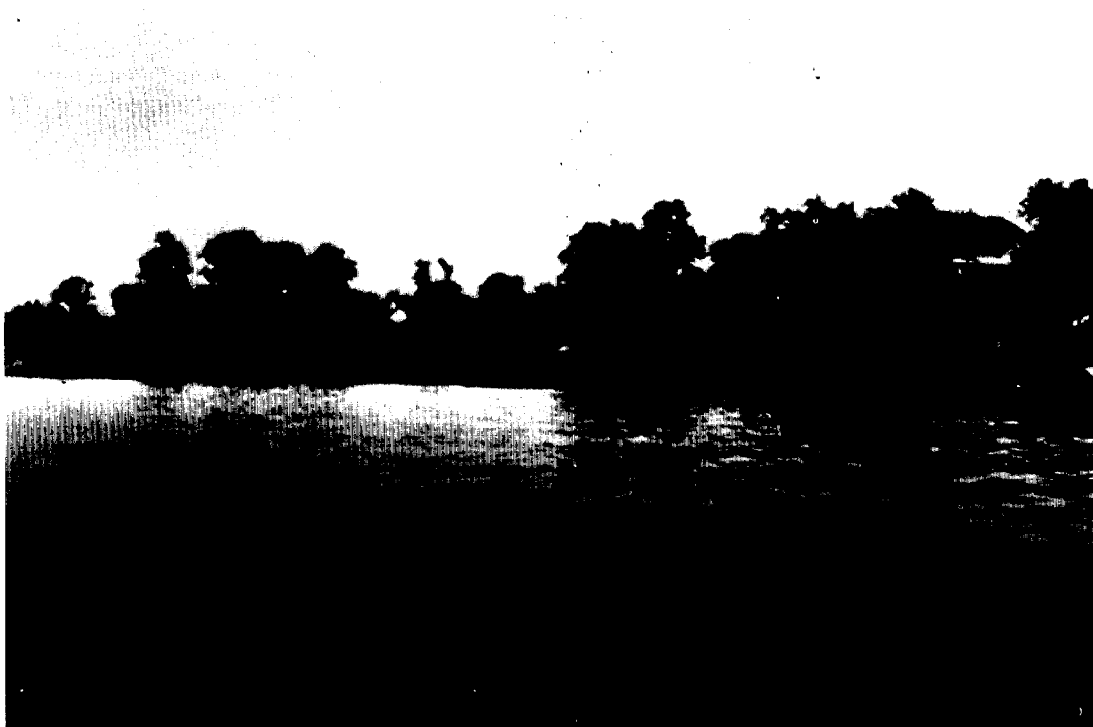
CASE 40 CONCRETE PIPES ON TILGHMAN ISLAND

This structure is in generally good condition. At the time of the site visit, there was a sand beach present. Alongshore to the south, trees are falling off the eroding bank. Alongshore in the other direction, the concrete pipes are installed in front of the bulkhead, and seem to be working fairly well in preventing erosion.
